Used Vehicle Inspection Report

The left and right quarters and fenders have bondo Both driver side doors have been replaced. There are sand marks in the bondo. Mechanically the vehicle was okay. The spare tire was not secure. There is no frame damage or rust. The driver's seat has some wear. The trunk latch trim was broken. There are stone chips in the hood.

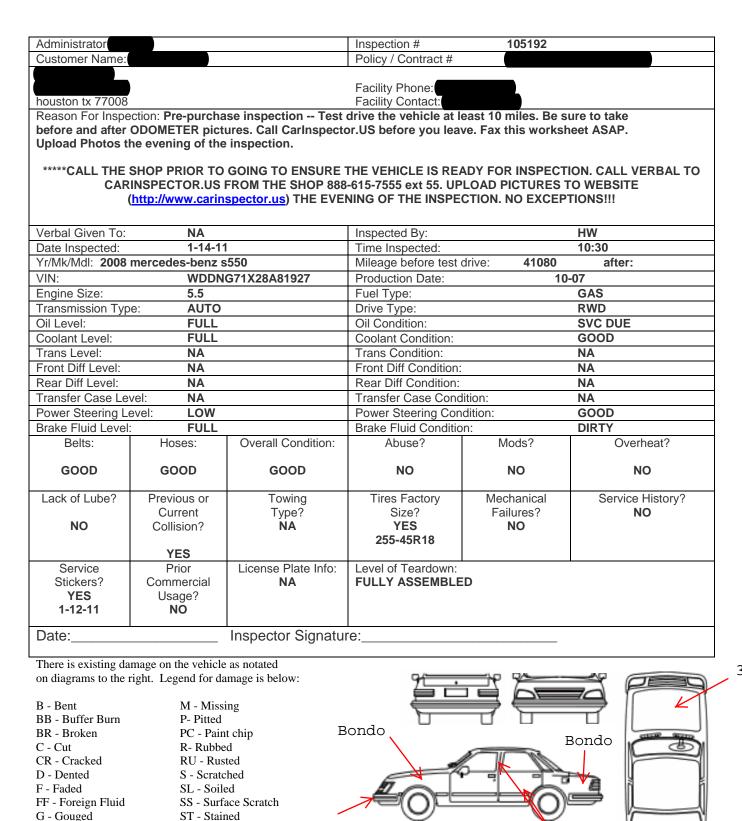
PC

Bondo

3 PC

Repair

Collision repair

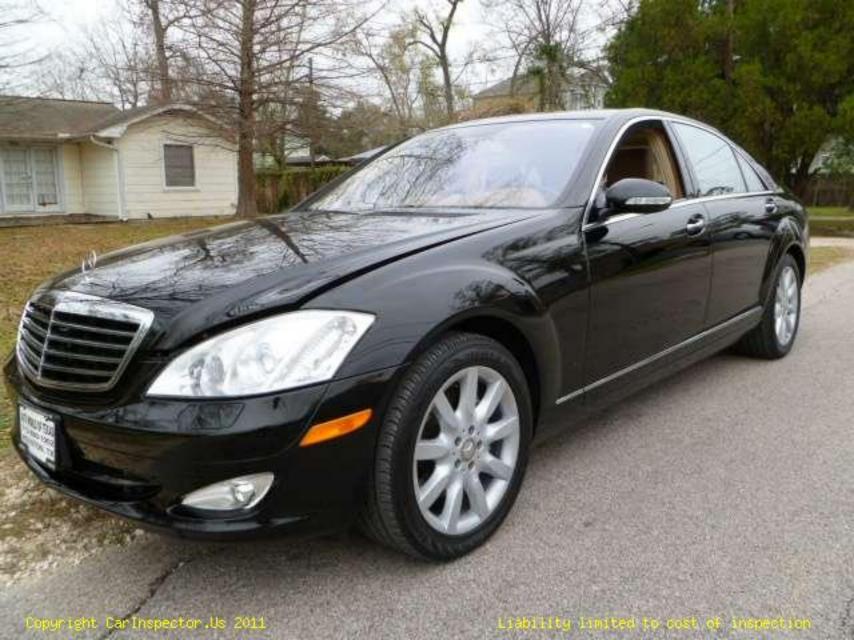
ERCHRYSLER AG STUTTGART DAIML PASSENGER CAR MADE IN GERMANY 10/07 LBS THIS VEHICLE CONFORMS TO ALL APPLICABLE 2565 5655 GVWR U.S. FEDERAL MOTOR VEHICLE SAFETY, BUMPER GAWR FRONT 1230 2715 AND THEFT PREVENTION STANDARDS IN EFFECT GAWR REAR 1335 2940 ON THE DATE OF MANUFACTURE SHOWN ABOVE DNG71X28A181927

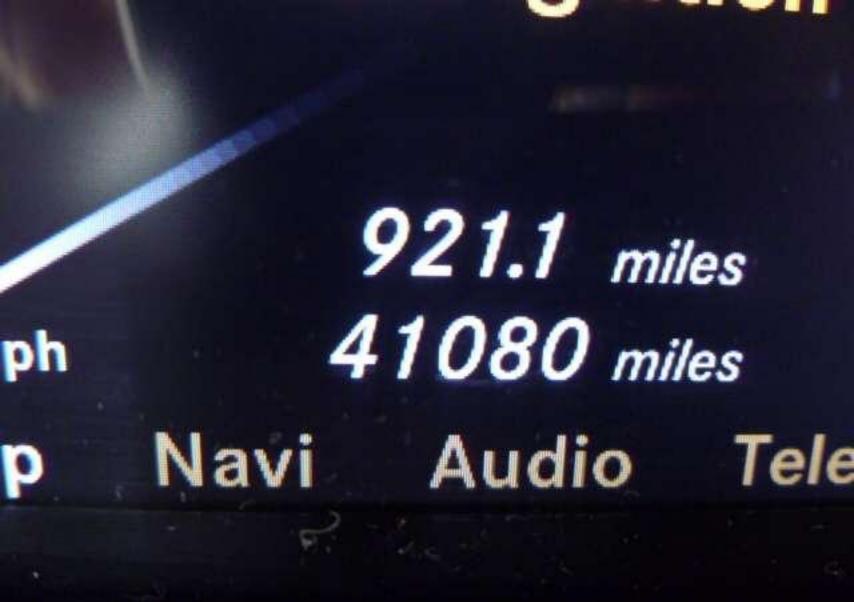
931.3 miles 931.3 miles 160 Trip Navi Audio Telephone

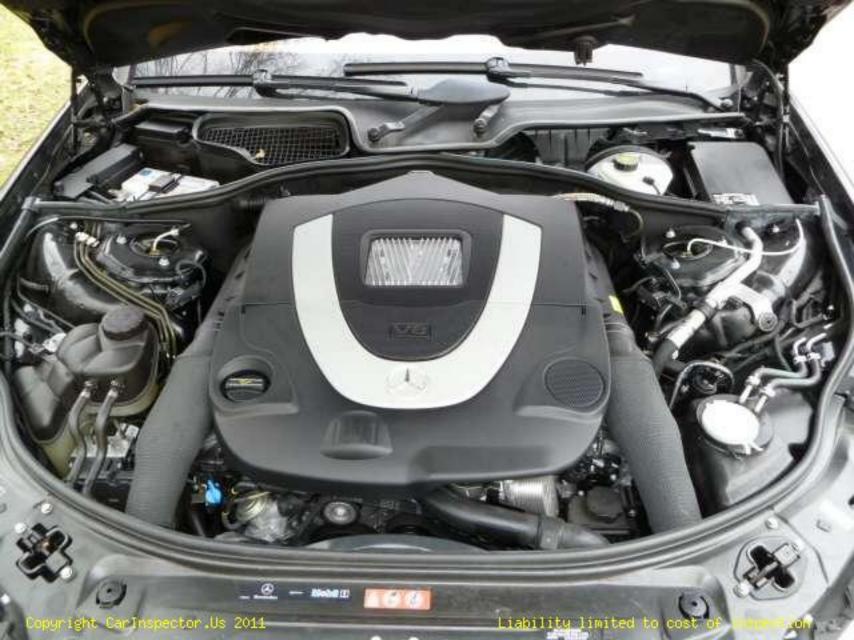
VEHIC			LER AGes-Beaz OL INFORMATION
Conforms	to regulations:	1 CA	2008 MY
U.S. EPA:	T2 BIN 5 LDV	OBD: CA II	Fuel: Gasoline
California:	ULEV II PC	OBD: CA II	Fuel: Gasoline
No adjus	stments needed.	SFI/AIR/2	HO2S(2)/2TWC
Group:	8MBXB05.5U2A		
EVAP:	8MBXR0170LNS		
Remarks:	n/a	and and and the second	A 1 45 01 5181962
